Manhole Inspection Summary

Manhole # S04YY1014MH

Location Address: **3812 CLARKS LN**

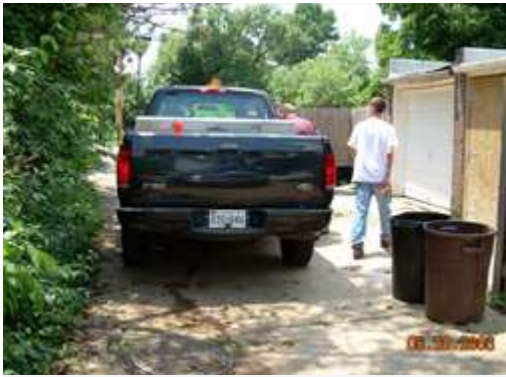
Location View

Comments **Located in the alley between Clarks Ln and Clarinth Rd. The I6 pipe picture shows Heavy grease deposits in the Channel.**
